A RGBD-based system for real-time robotic defects detection on sewer networks

L. Merino, D. Alejo, S. Martinez-Rozas and F. Caballero

Service Robotics Laboratory, Universidad Pablo de Olavide, Seville, Spain.
{lmercab,daletei,fcaballero}@upo.es
s.martinez.r@ieee.org

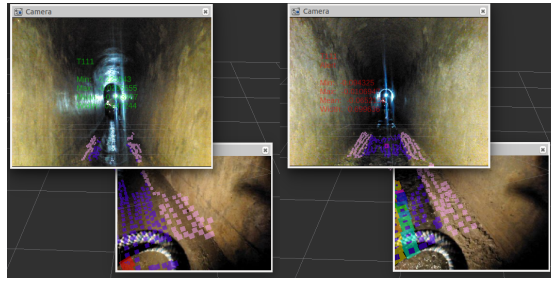
Fig. 6. Left: the serviceability of the gallery is correct. The frontal and down right cameras are shown (there is a down left camera that is not shown for clarity). In green, the absolute values for the height of the gutter are displayed in the frontal image for the operator. In purple and pink, the 3D points corresponding to the gutter and curb respectively. Right: serviceability alarm. The values are displayed in red. Many of the 3D points in the down-right camera (marked as colored points) are detected as departing from the ideal section (the gutter is blocked by debris).

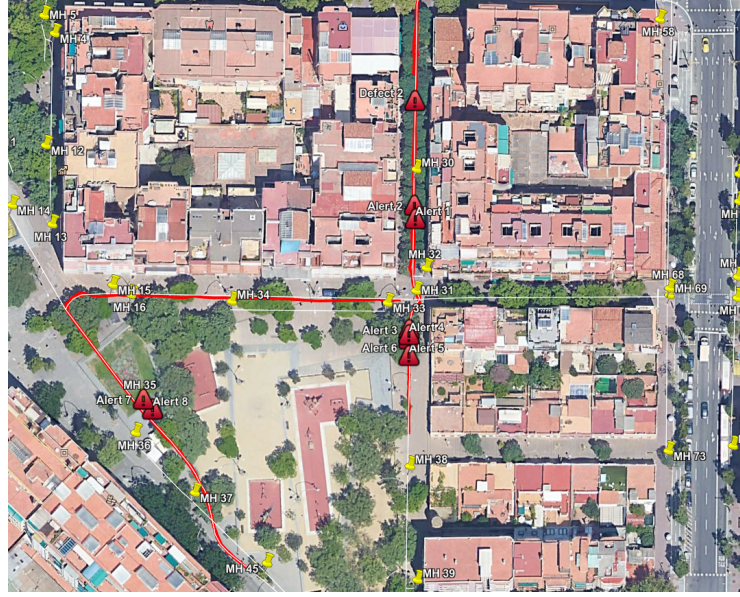
During the inspection, four serviceability defects were automatically detected and localized by the platform. In particular, our algorithm detected two main zones where there are very noticeable defects where human intervention would be needed for cleaning purposes.

Fig. 9. Inspection report of the experiments at Virrei Amat square. The path followed by the SIAR platform is marked in a red line. The generated alerts by the system are shown in red exclamation marks.

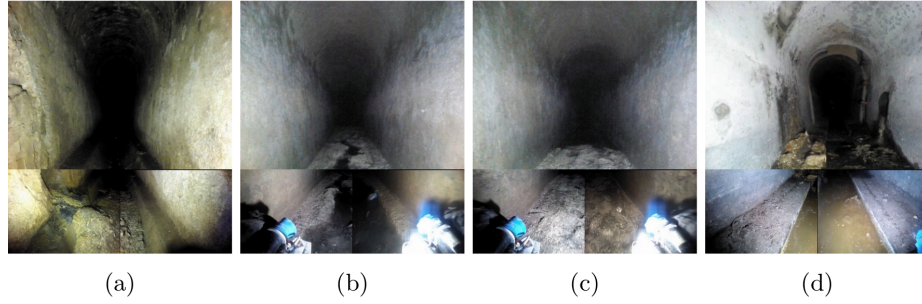
Fig. 10. (a-d): Composed snapshot in Alerts 1-4 in Virrei Amat, respectively.

Serviceability defect 1: Alerts 1 and 2. Fig. 10-a shows a composition of the three images from the frontal cameras. In this case, there are noticeable sediments on the gutter and in the leftmost curb.

Serviceability defect 2: Alerts 3 and 4. Fig. 10-b presents a composition of the three images from the frontal cameras. In this case, sediments are accumulated in the gutter and they prevent the water from flowing.

Serviceability defect 3: Alerts 5 and 6. Fig. 10-c presents a composition of the three images from the frontal cameras. Sediments are accumulated in the gutter and prevent the water from flowing. The accumulated water at the end of the serviceability defect can be found in the video ⁴.

Serviceability defect 4: Alerts 7 and 8. Fig. 10-d presents a composition of the three images from the rear cameras. We found a noticeable sediment over the rightmost curb and some sediments at the gutter.

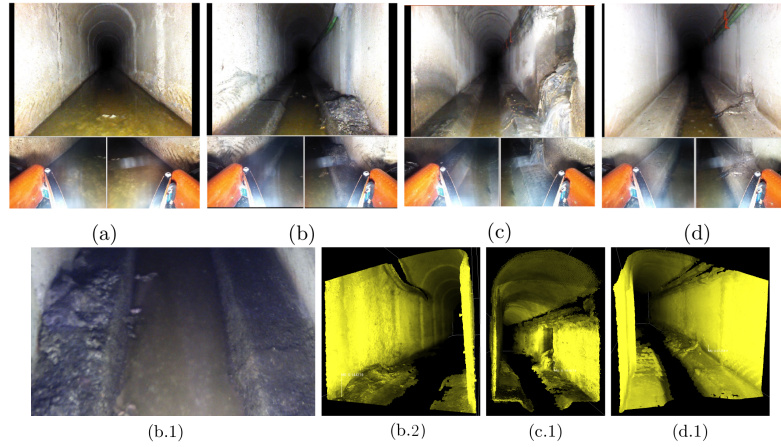
Serviceability defect 1: Alerts 1 and 2. The system detected an anomaly in the serviceability in the first part of the inspected area. In this case, the water covered the complete surface of the floor and thus the anomaly was reported. The obtained data indicates an anomaly in the gutter levels as shown in Fig.12-a.

Structural defect 1: Alert 3. Structural defect 1. Fig. 12-b and 12-b.1 show the visual and 3D representations, respectively. In this case, a noticeable obstacle of 14.4 cm can be found in the rightmost curb.

Structural element 1: Alert 4. The system detected an inlet in one of the sides of the gallery. Fig. 12-c and 12-c.1 show visual and 3D representations of the surroundings of the inlet, respectively. We estimated its height on 19.1 cm, which can be of use for determining if it has been built according to the laws.

Structural defect 2: Alert 5. Fig. 12-d and 12-d.1 show visual and 3D representations, respectively. We observe a 7.2 cm tall inlet with its sediments.

Fig. 12. (a) Composed snapshot in Serviceability Defect 1 of the experiment in Pas-seig Garcia Faria. (b) Composed snapshot in Structural Defect 1, with an obstacle in the rightmost curb. (b.1) Detail of the obstacle obtained with the arm camera (b.2) Obtained 3D mesh in Structural Defect 1 (the obstacle is on the left). (c) Composed snapshot in Structural Element 1. There are some sediments under an inlet on the rightmost curb. (c.1) 3D mesh in Structural Element 1. (d) Composed snapshot in Structural Defect 1. It is on the rightmost curb and is composed by sediments that come from an inlet. (d.1) 3D mesh in Structural Defect 2.
